Analysis on Quenching Cracks of Engine Crankshaft

Abstract: Engine crankshaft of cracks macro and micro were analyzed by morphological characteristics and quench cracks organization identified as the quenching crack, but further study showed that the root cause of this quenching cracks generated not due to the heat treatment process or other causes, but due to poor uniformity of the hot iron casting, elements gathered along the grain boundary segregation.

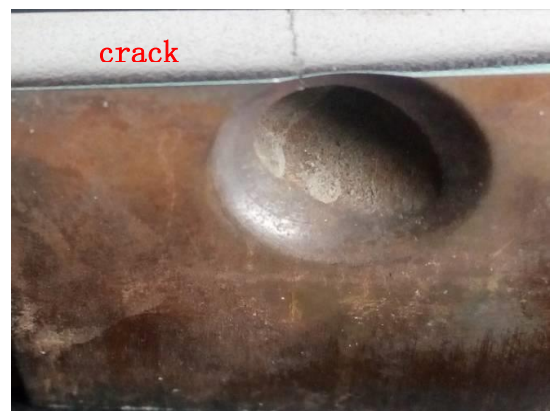
Observe all cracks in the crankshaft, found that the crack is located in the connecting rod and spindle oil hole chamfer position and the bottom of the thinnest wall, and to the oil hole chamfering the inner wall and journal extension shown in Figure 1.

Fig.1.crack macroscopic morphology

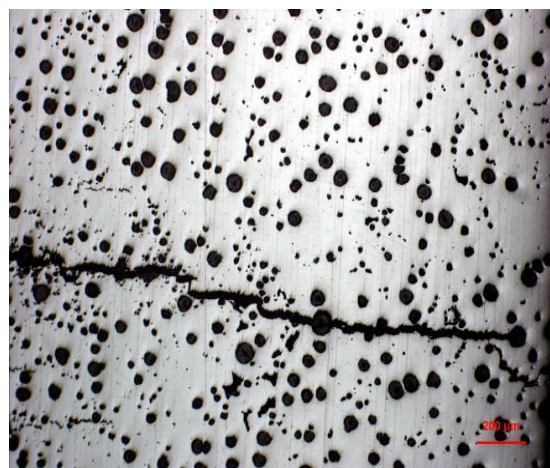
Fig.2.crack micro-morphology(50X non-corrosive)

The microscopic detection of the opening of the oil hole crack. Figure 2 and Figure 3 show the microscopic morphology of the crack. It can be seen from Figure 2 that although the main crack is sometimes broken in the middle, but the overall look at the main cracks originated in graphite. The crack passes along the graphite, and the main crack shape is strong and powerful. Cracks seem to tear because of force, and the direction of straight. Some small cracks originate in graphite, tail tip.

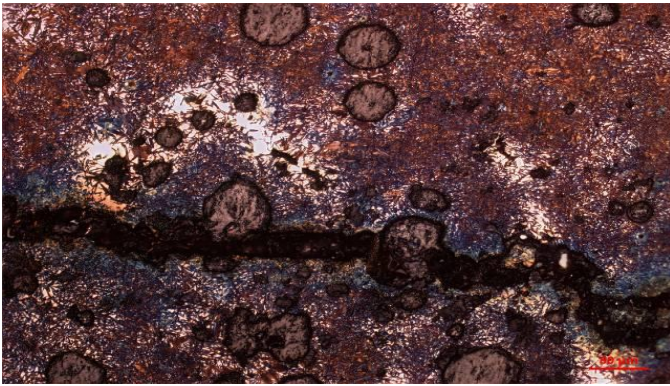
Fig.3.crack micro-morphology (200X has been corroded)

Ductile iron workpiece quenching cracks for many reasons, such as improper cooling, inclusions, spheroidization, complex parts and the quenching temperature is too high [3]. The quenched crack in Figure 3 is due to two stresses, ie, thermal stress and tissue stress. The former is caused by uneven cooling, the latter is austenite into martensite generated. When quenching and cooling, these two stresses tend to concentrate at the edge of graphite and cause cracking.

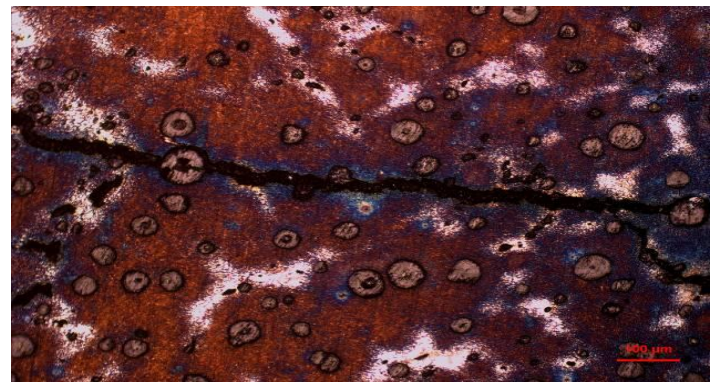
The main crack on both sides of the phenomenon of non-oxidative decarburization, it can be sure there is no crack before quenching (see Figure 4). During the quenching and cooling process, the crack may form only when the martensitic transformation reaches a certain amount. Corresponding to this temperature, about 250 °C below. At such a low temperature, even if cracks are generated, decarburization and significant oxidation not occur on both sides of the crack. Therefore, the phenomenon of oxidation decarburization is non-quenched crack. If the crack is already present before quenching and does not communicate with the surface, such internal cracks will not produce oxidative decarburization, but the lines of the crack appear soft, the tail is round bald, The lines of this crack are also easily different from the lines of the quenched crack, this crack are also easily different from

Fig.4. crack near the quenching organization (100X has been corroded)

- (1)Residual austenite content > 10% at 100X;
- (2)most of the small graphite along the grain boundary distribution;
- (3)residual austenite along the small graphite distribution;

According to JB/T 9205-2008 "pearlitic ductile iron parts induction quenching metallographic examination" on the quenching area to determine the organization: quenching organization 2-3; coarse martensite, large block retained austenite, cementite, Spherical graphite. Conclusion: Quenching tissue is not qualified.

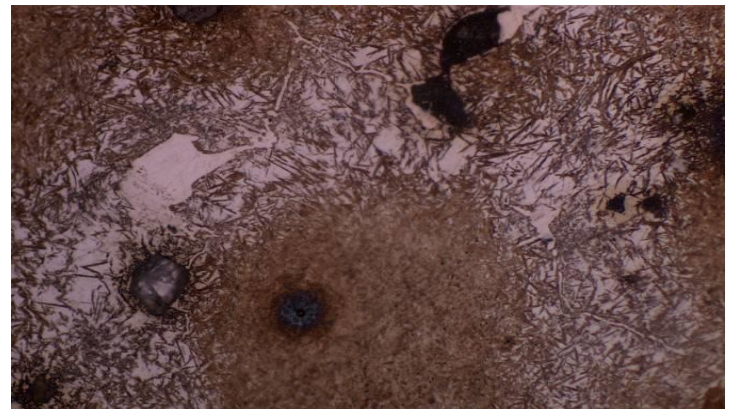
Fig.5. crack near the quenching organization (500X has been corroded)

(4)500X under the observation of a network of cementite along the grain boundary distribution; (5)residual austenite and cementite area martensite coarse; (6)the white area is a mixed structure of retained austenite and carbide.
